M6-400 (PC GREEN)

CHARACTERISTICS

COMPONENTS AND JUMPERS ON MOTHERBOARD T.1.5 (BA2067) (BA2070)

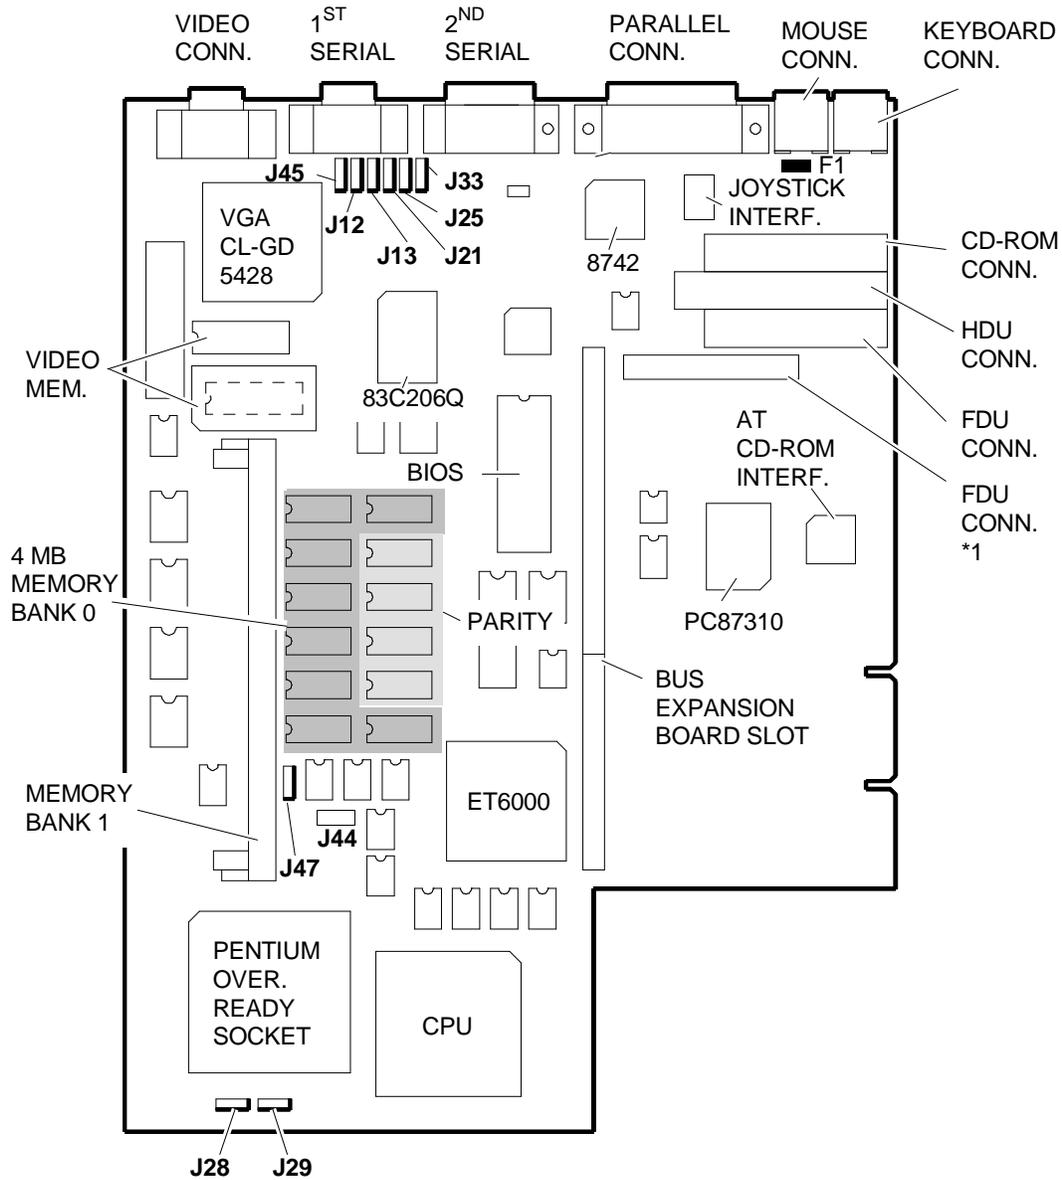
COMPONENTS ON SIDE A

EXM9A

*1 FOR PERSONAL COMPUTERS WITH MICROTOWER CASE ONLY

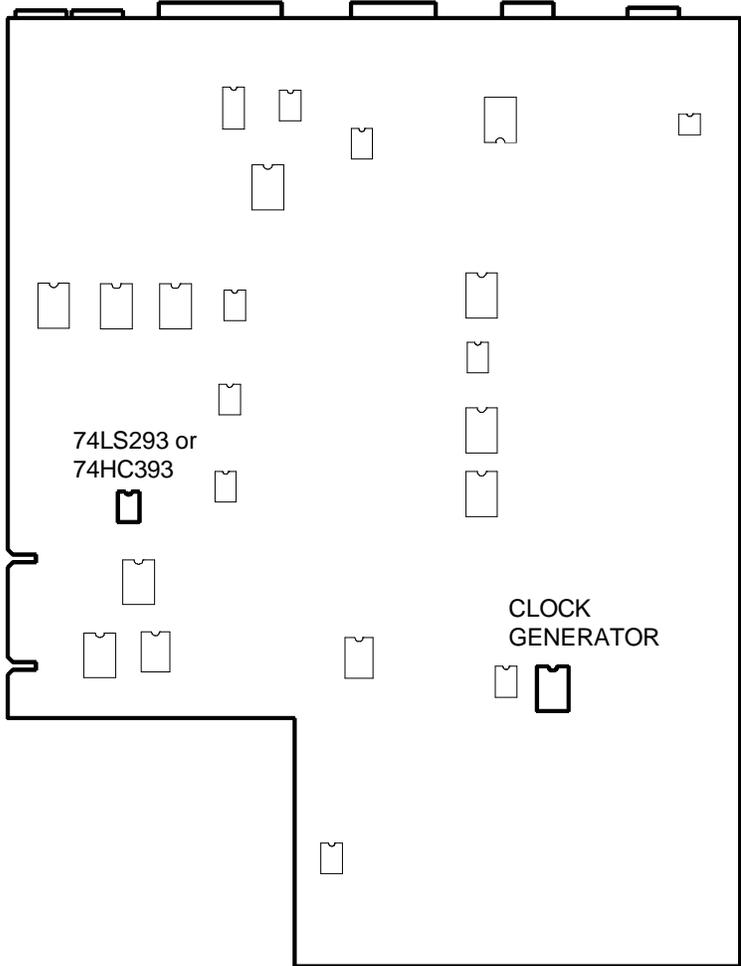
COMPONENTS ON SIDE B

EXN3A

JUMPERS ON MOTHERBOARD T.1.5 (BA2067) (BA2070)

Jumper J21 (Serial Port 1) and J25 (Serial Port2) - Serial port control.

Jumper J33 - Floppy disk write protect

Jumper J12 - Setup control.

Jumper J13 - Mouse interrupt

Jumper J44 - CPU clock selection

Jumper J47 - AT bus status selection

Jumper J45 - VGA video controller setting

Jumpers J29 - J28 - Type of processor installed
