**Processor Technology**

Three layout errors exist on the Sol-KBD PC board you received. These errors must be corrected before you check the circuit board and start assembly. How these errors are corrected are described below:

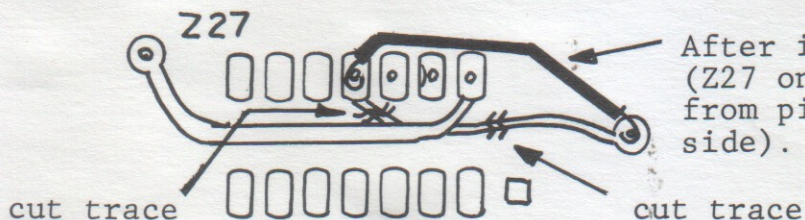
1. Key Pad #55

2. U18, Pin 8

3. U27, Pin 11

cut trace

Using a sharp point, cut the bridge between the pad at 55 and the trace above (solder side).

After installation of socket at U18 (Z18 on etch), install jumper wire from pin 8 to ground trace as shown. (Solder side.)

After installation of socket at U27 (Z27 on etch) install jumper wire from pin 11 to pad as shown (solder side).
